NASA CR-165664

Advanced Composite Aileron For L-1011 Transport Aircraft-- Ground Tests And Flight Evaluation

C.F. Griffin

Lockheed Corporation
Lockheed-California Company
Post Office Box 551
Burbank, California 91520

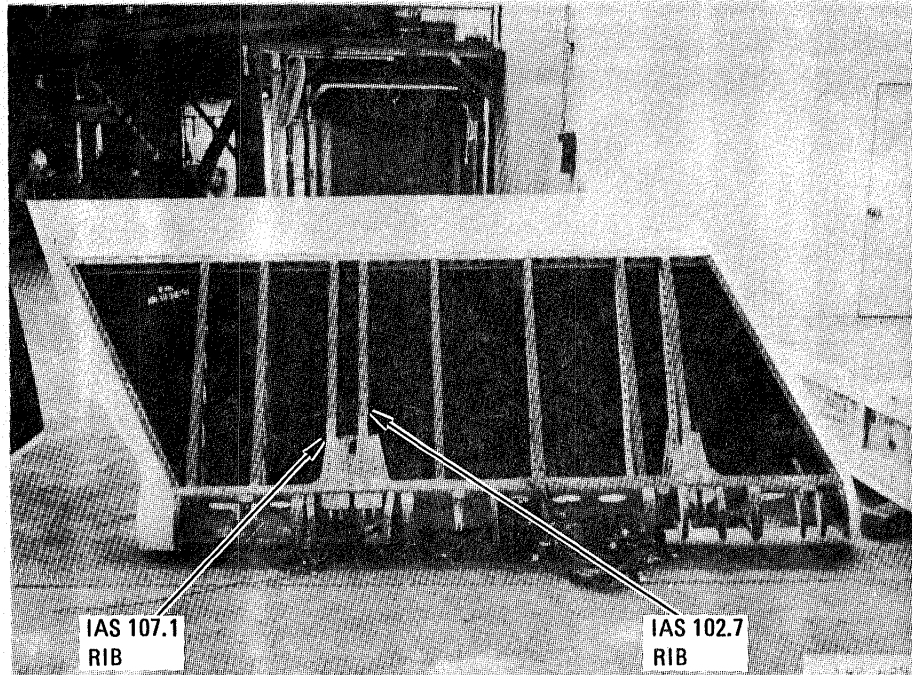
Figure 20. - Static ground test article with lower cover removed.

Following these tests the aileron was loaded to failure in the Condition 1 configuration. Failure occurred at 139 percent DUL. The lower cover was removed (figure 19) to permit examination of the failed members. Neither the covers nor the front spar experienced visible damage. The station 102.7

main rib web failed in a post-buckling mode with the web tearing at the bathtub fitting near the front spar and failing in bending along the crest of the shear buckle (see figures 21 and 22). The main rib web at station 107.1 also failed in buckling with the bending failure crossing the two forward access holes (figures 23 and 24). It is not possible to distinguish the sequence of failure of these two ribs because the measured actuator link loads at I.A.S. 102.7 and I.A.S. 107.1 show a load drop-off at exactly the same instant.

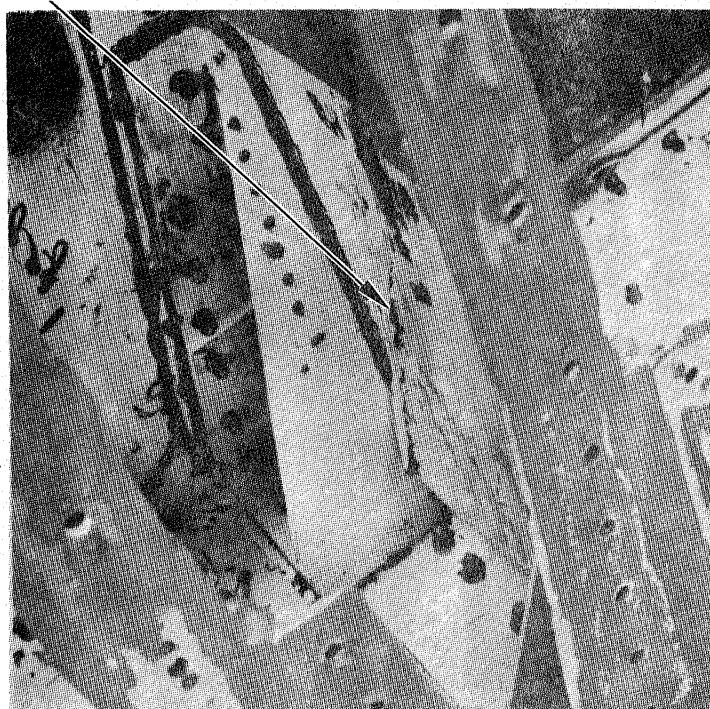
Failure location

The load-strain response of the various elements within the aileron were similar to the Condition 4 load response in that most of the behavior was linear to 100 percent of DUL. As expected the lower cover buckled in compression in the spanwise direction. Analyses of the back-to-back rosettes on the hinge/actuator rib at I.A.S. 102.7 indicated initial buckling of the rib web at approximately 95 percent of DUL. The failure mode of the rib web appears to be a tensile failure precipitated by shear buckling of the web.

Figure 21. - Closeup view of I.A.S. 102.7 rib showing Web failure-outboard side.

The structural analysis of the rib webs at I.A.S. 102.7 and 107.1 had predicted buckling would occur at loads much greater than ultimate. This analysis was based on data from a three-dimensional finite element model in which the elements of the rib models were relatively large and thus the internal loads were dissipated over longer paths.

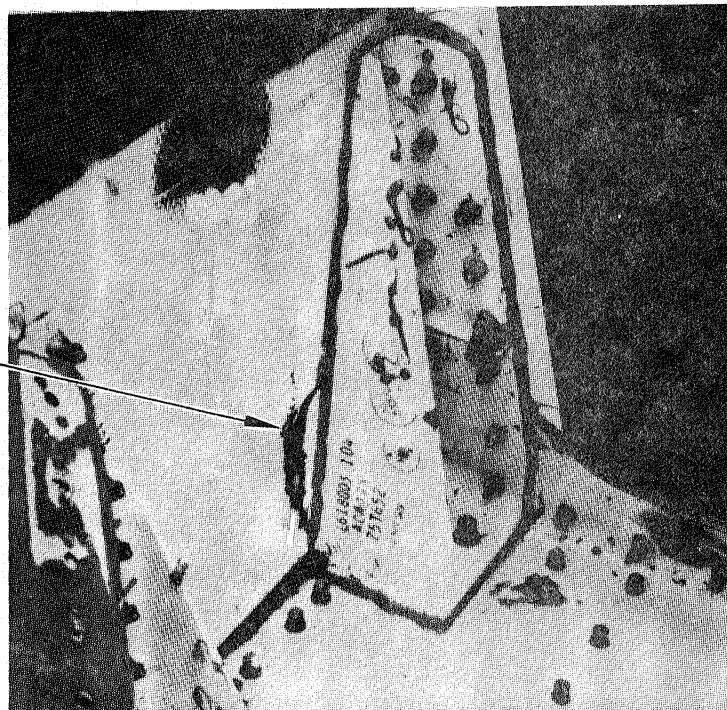
Failure location

Figure 22. - View of I.A.S. 102.7 rib showing Web failure-inboard side.

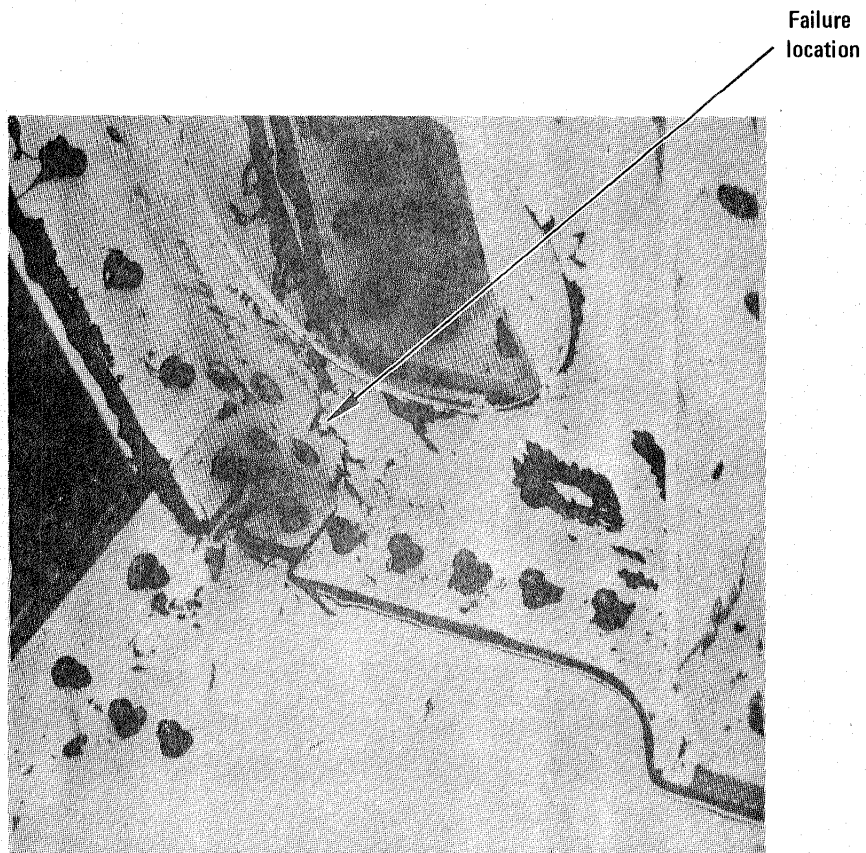
Figure 23. - Closeup view of I.A.S. 107.1 rib showing Web failure-outboard side.

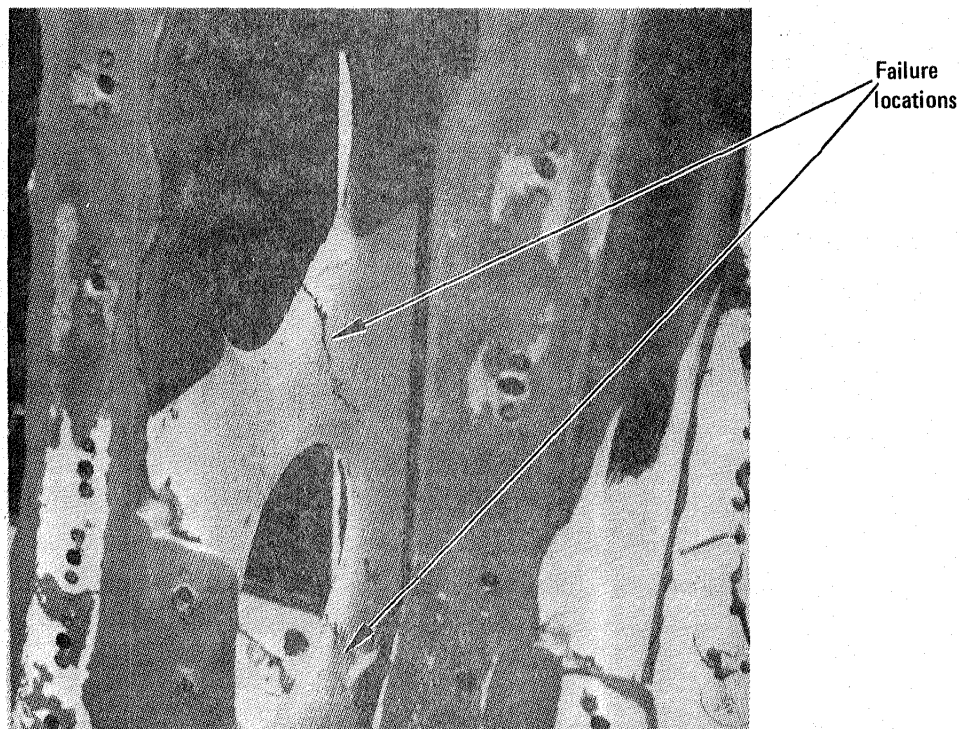
Figure 24. - View of I.A.S. 107.1 rib showing Web failure-inboard side.

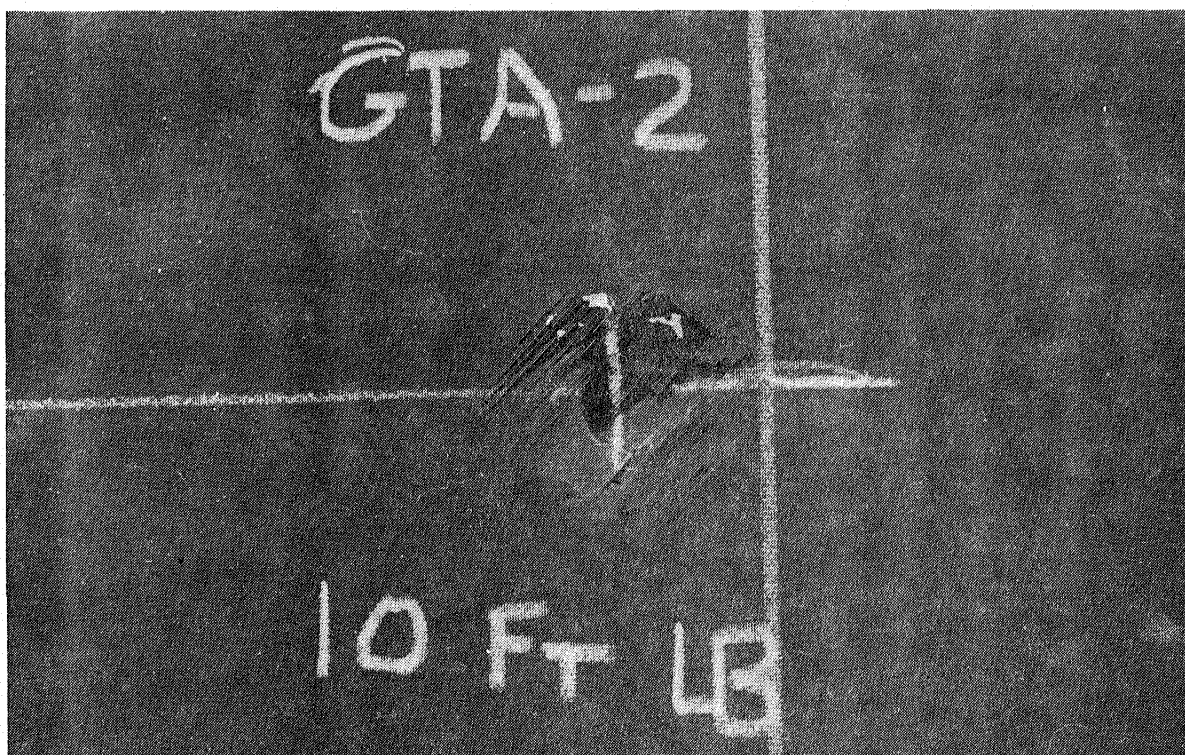
Four locations on the aileron were selected for inflicting damage, the upper cover, the main rib cap, the front spar web, and the forward spar cap flange of the lower cover. The upper cover was impacted with 13.6 Joules (10 ft-lb) of energy. A 25.4 mm (1.0 in) diameter hemispherical steel impactor was used. The impact location was in the midst of the buckling region, at I.A.S. 85.7, 178 mm (7 in) aft of the front spar datum. The upper cap of the I.A.S. 102.7 rib was cut prior to assembly. The cut extended from the edge of the fastener hole, located 244 mm (9.6 in) aft of the front spar datum, through the cap thickness to the free edge of the cap. With the impactor described above, the front spar web was impacted with 8.1 Joules (6 ft-lb) of energy. The impact location was I.A.S. 105.0, approximately 89 mm (3.5 in) above the lower cap. The forward flange of the lower cover was impacted with 13.6 Joules (10 ft-lb) of energy. This region acts as part of the front spar cap. The impact location was I.A.S. 99.0, approximately 12.7 mm (.5 in) aft of the free edge. All of these impacts caused visible damage on both the front and back surfaces of the component. Nondestructive inspections were made to quantify the amount of damage. A photograph of the damage to the upper cover is shown on figure 27.

Figure 27. - Upper cover impact damage.

impact damage on the upper cover. The damage had increased in size from a 51 mm (2.0 in) diameter circle to an ellipse with a major axis dimension of 152 mm (6.0 in). Subsequently, 117 percent of limit load for Condition 1 and 117 percent of limit load for Condition 4 were applied to demonstrate that this damage had not grown to critical size. The load/strain data taken during these tests were not significantly different from those obtained from similar tests applied to the undamaged ground test article. The exceptions include the gage near the cut rib cap at I.A.S. 102.7, where the axial strains were 20 percent less; and the back-to-back rosettes on the front spar web at I.A.S. 105 near the impact damage, where the shear strains were 10 percent less.

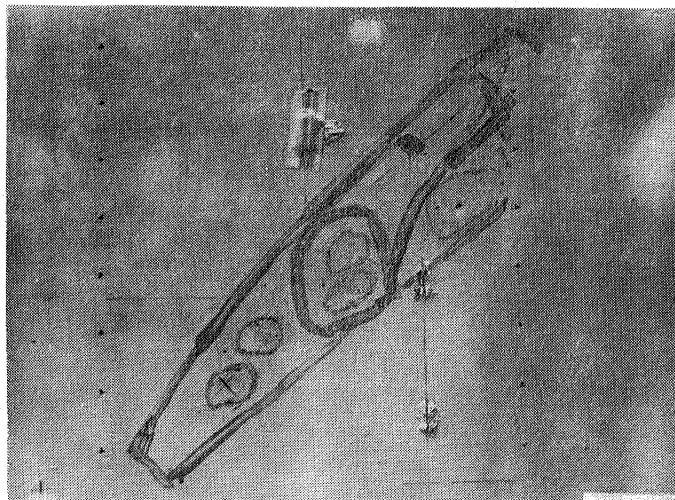
The area selected for the damage was the lower cover at I.A.S. 85.7, 191 mm (7.5 in) aft of the front spar. To simulate the damage from swept-stroke lightning the following procedure was utilized. The cover was subjected to five impacts of 10.8 J (8 ft-lb) of energy each along a 45° line spaced approximately 51 mm (2 in) apart. A 25.4 mm (1.0 in) diameter steel rod with a hemispherical tip was used to make these impacts. Ultra-sonic inspection of the cover after the impacts (shown in figure 28) verified that substantial delamination occurred over a region of 381 mm (15 in) by 76 mm (3 in). A welder's electric arc was then used to burn a hole in the middle of the delaminated area, see figure 29. An oxygen/acetylene torch was then used to burn the surface of the entire delaminated area. The resulting damage, shown on figure 30, satisfactorily simulated the effects of swept stroke lightning.

Figure 28. - Lower surface impact delamination (front face).

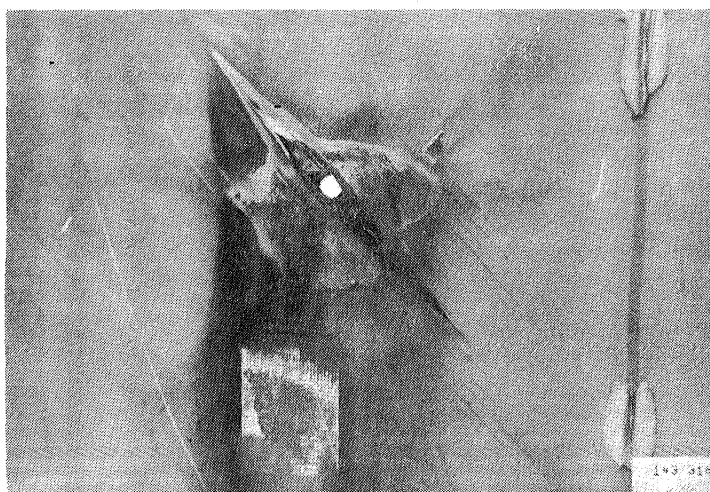
Figure 29. - Lower surface burn-through and impact damage (back face).

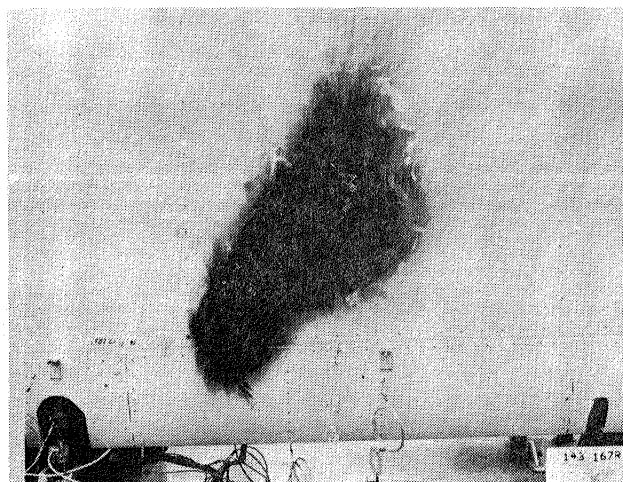
Figure 30. - Lower surface swept-stroke damage simulation.

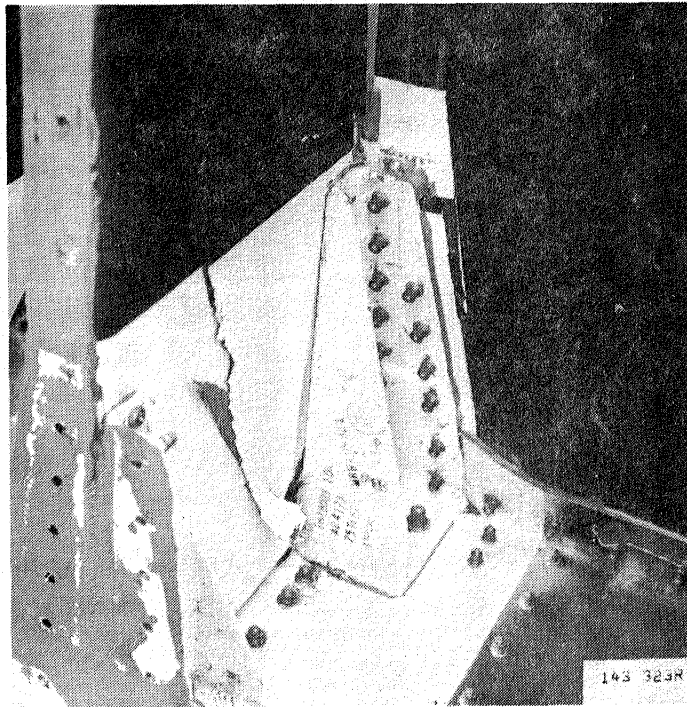
Following all of these tests the aileron was loaded to failure in the Condition 1 configuration to determine its residual static strength. Failure occurred at 130 percent of design ultimate load in the postbuckling rupture of the rib webs at stations 102.7 and 107.1, shown on figures 31 and 32. The failure mode was the same as occurred for the static test article, but the failure load was 93.5 percent of the failure load for the undamaged test article. Other than the effect of internal load redistribution there was no evidence that any of the damage sites directly contributed to the failure. Following the initial failure at 130 percent of design ultimate load the load jacks continued to apply another 9 percent of design ultimate load before the load was dumped. This overload led to the failure of the station 57.1 rib web, followed by a failure of the covers and hinge fitting forging.

Figure 31. - I.A.S. 102.7 rib web failure, residual strength test.

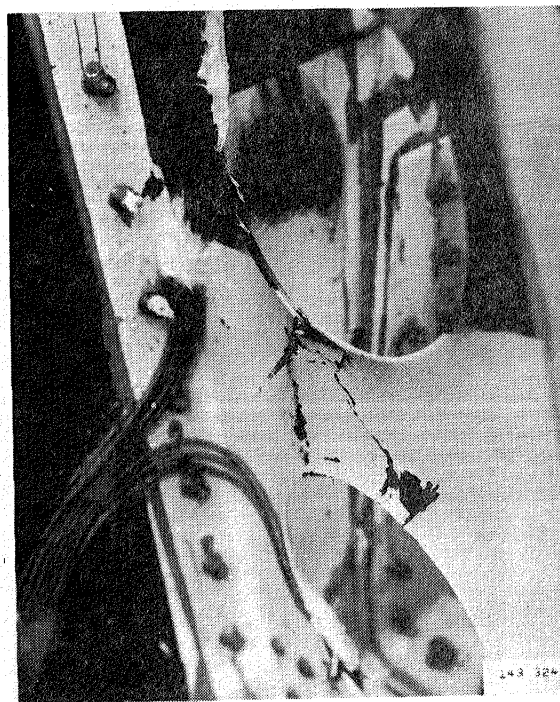
Figure 32. - I.A.S. 107.1 rib web failure, residual strength test.
